October 28, 2021

Version 3

Emissions Recall: 2020 Accord and Accord Hybrid Fuel Tank

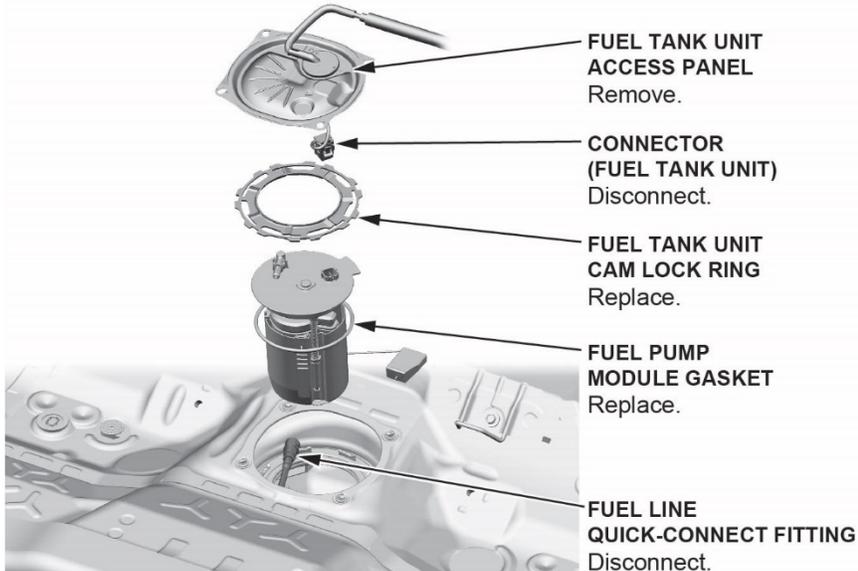
1. Relieve the fuel pressure.
2. Remove the rear seat cushion.
3. Remove the fuel tank unit access panel.

4. Disconnect the connector.
5. Disconnect the fuel line quick-connect fitting.
6. Unlock the fuel tank unit cam lock ring.
7. Remove the fuel tank unit.
8. Drain the fuel tank.
9. Remove the driver's side rear wheel.

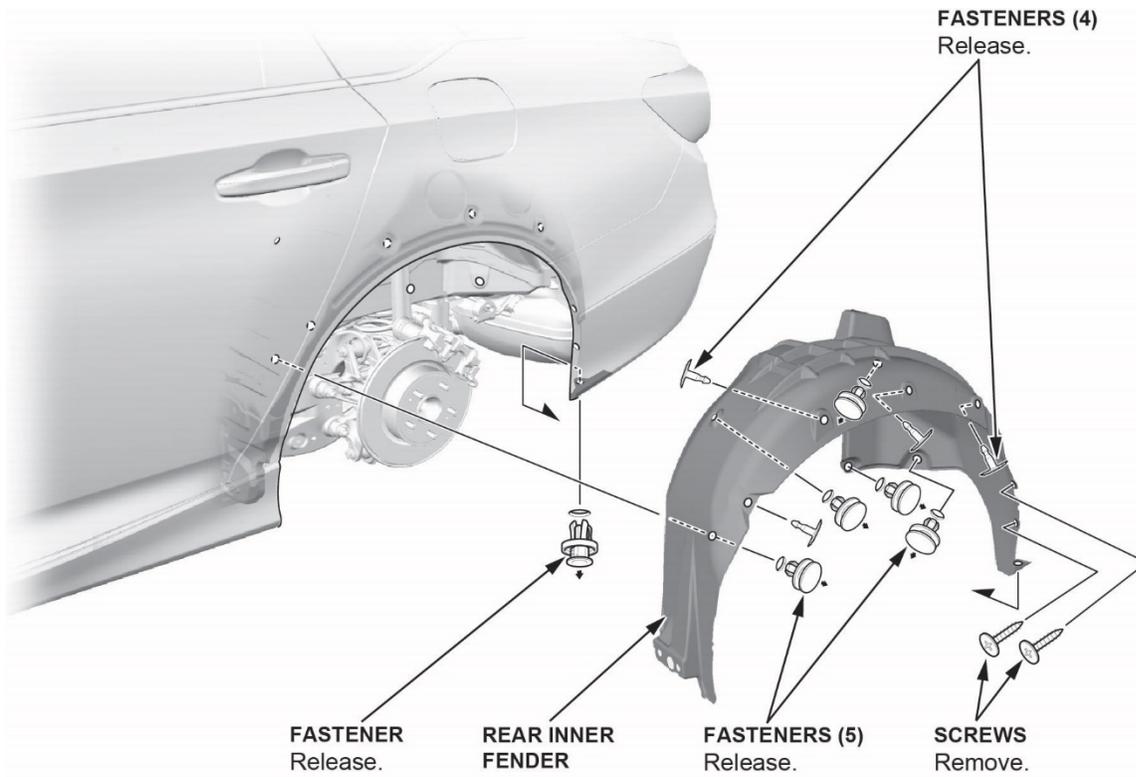
10. For some models, remove the driver's side rear inner fender.

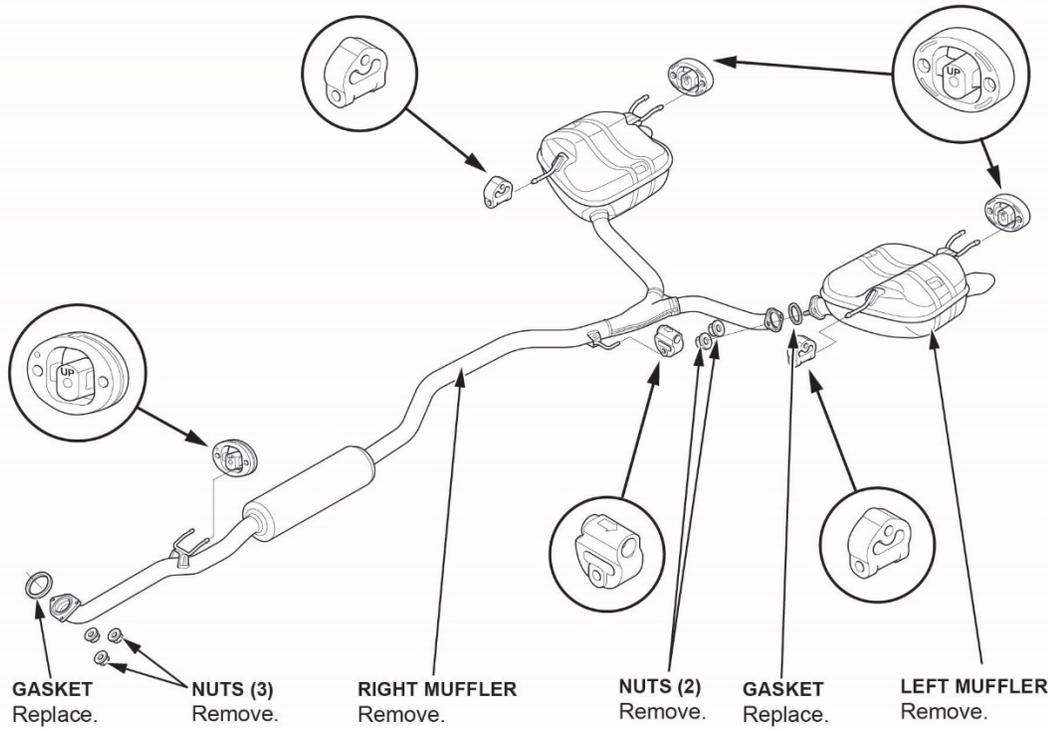
ACCORD 1.5L

11. Remove the muffler.

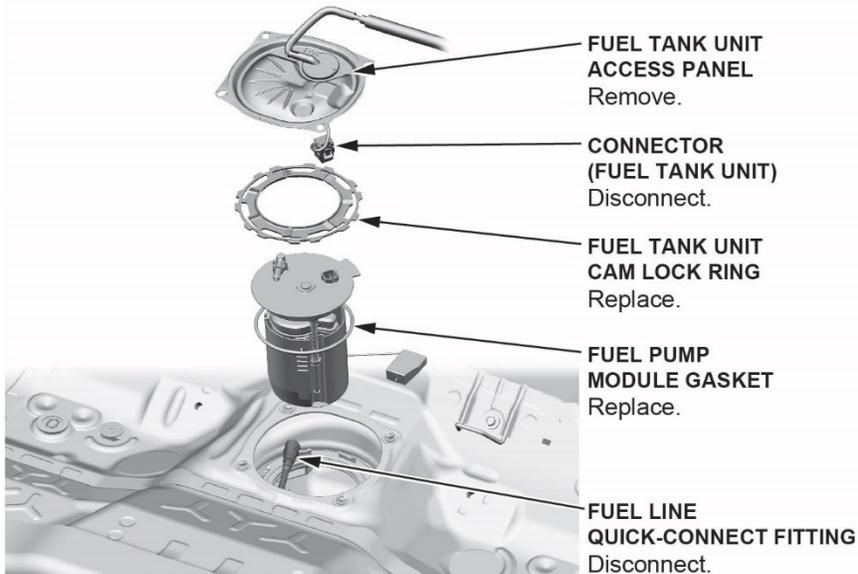
1. Relieve the fuel pressure.
2. Remove the rear seat cushion.
3. Remove the fuel tank unit access panel

4. Disconnect the connector.
5. Disconnect the fuel line quick-connect fitting.
6. Unlock the fuel tank unit cam lock ring.
7. Remove the fuel tank unit.
8. Drain the fuel tank.
9. Remove the driver's side rear wheel.

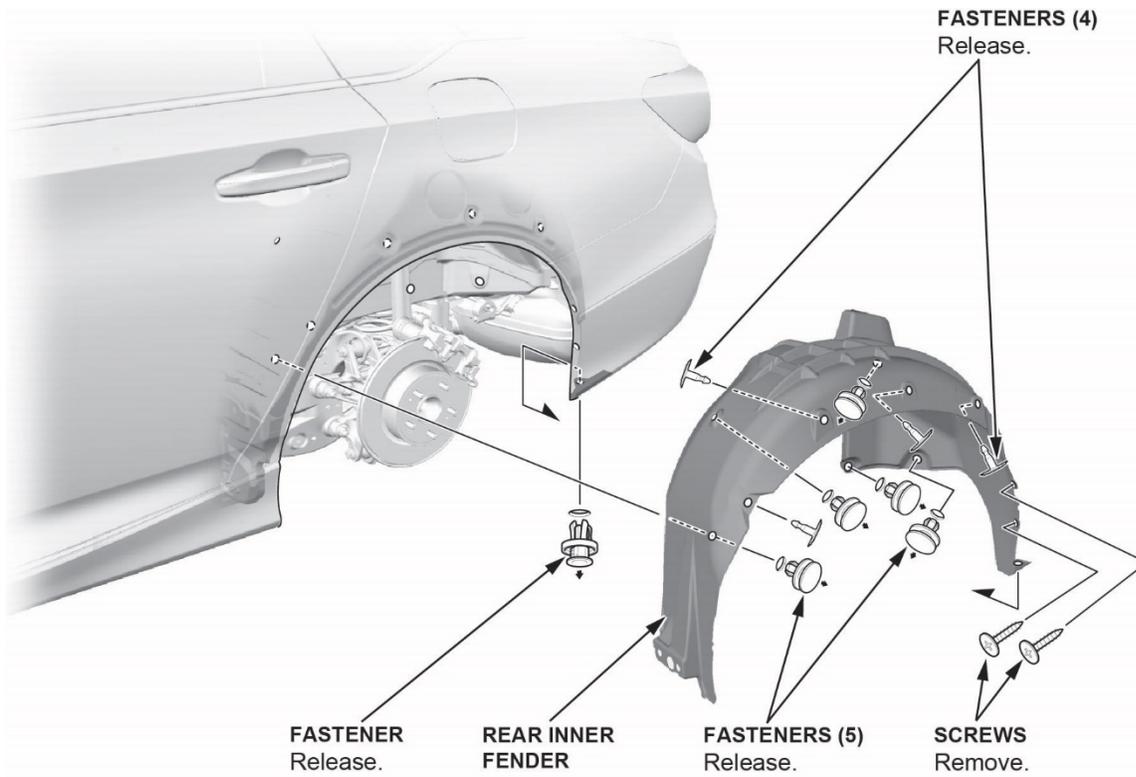
10. For some models, remove the driver's side rear inner fender.

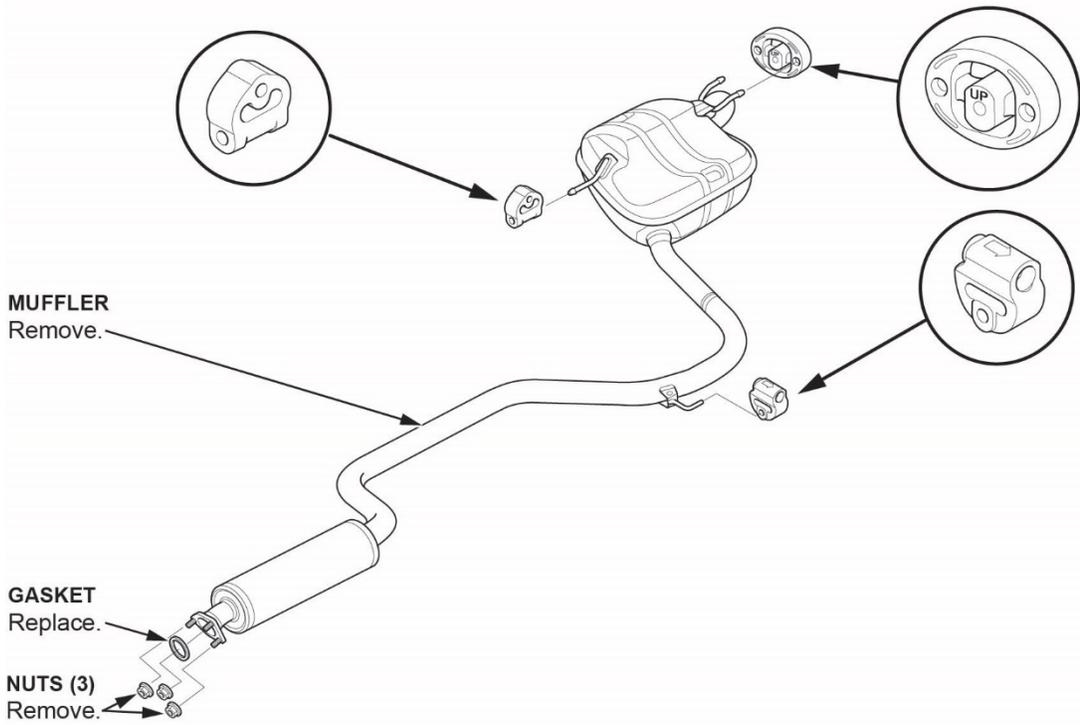
ACCORD HYBRID

11. Remove the muffler.

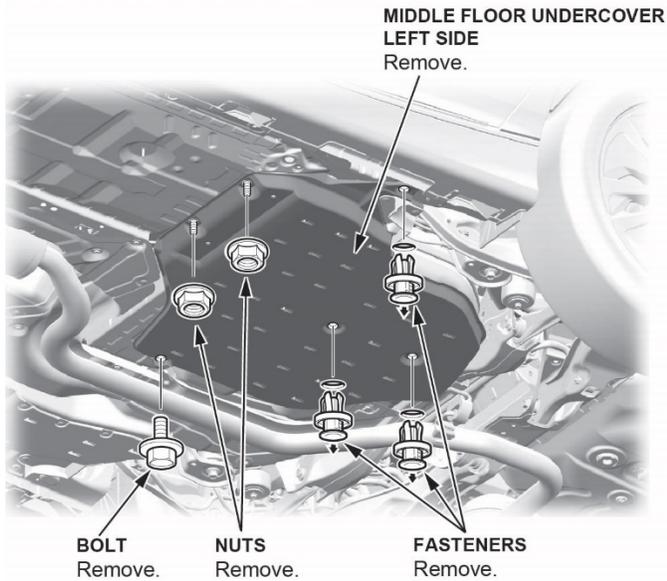
ACCORD HYBRID LEFT SIDE

12. Remove the middle floor undercovers.
